PROJECT: Natural Gas Pipe Repair
OWNER: Florida Power and Light Power Plant, Fort Lauderdale, Florida
DATE: December 2015
PRODUCTS: MCOR[™] 3115 | mClad[™] mFill[™]

When Surface Prep Is Not an Option, MCOR[™] 3115 Can Do the Job

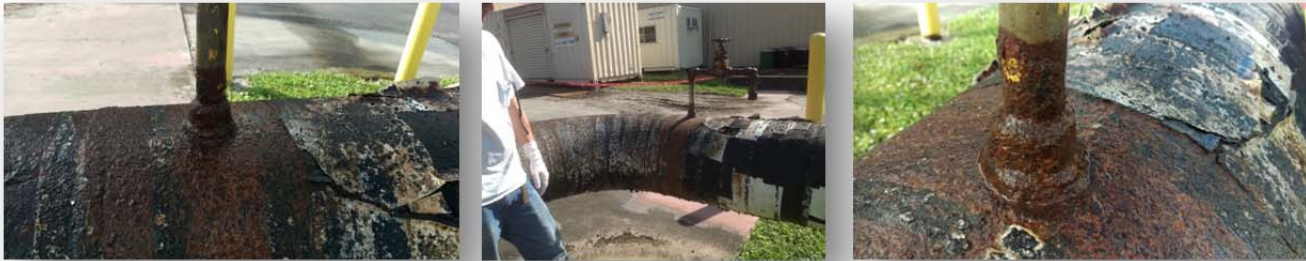
In late 2015, MCOR[™] assisted in rehabilitating a natural gas pipe at a Florida Power & Light (FPL) power plant located in Fort Lauderdale, Florida. This twenty-inch (20") natural gas pipe with two standoff one inch (1") pipes was in need of immediate repair. Both standoff pipes, along with their attachments to the main pipe, suffered from extreme erosion, and this effect was compounded by Corrosion Under Insulation (CUI). In addition to the corrosion issues, the surface was cold and constantly damp due to the condensation.

To gain more information about the substrate, including the wall thickness, FPL performed sonogram and X-ray tests as a preliminary step. The results showed that typical surface preparation methods could not be utilized due to the risk of further metal loss. The probability and risk associated with abrasive blasting or grinding tools puncturing through the pipes were too high; therefore, the possibility of getting the surface ready to accept any type of polymer

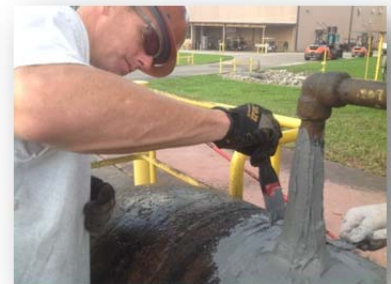
Applying the first coat of MCOR 3115

To begin the repair, the deteriorated section was isolated, providing a dry substrate. With two men on the job and the ambient temperature in the low 80°F range, the first coat was applied and allowed to cure overnight.

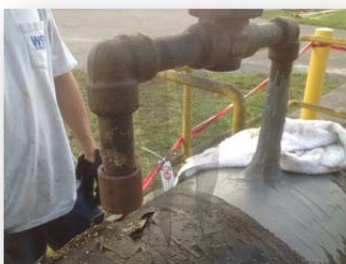
Thin second coat

Reinforcement mesh was applied the next day after the area was thinly coated with a second coat of the MCOR™ 3115, allowing it to work its way through the mesh. A third coat was applied to finish the application.

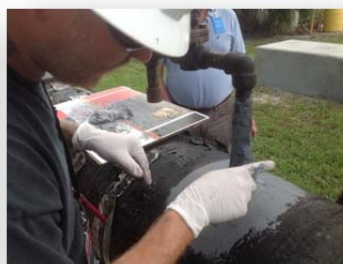
Application of mesh

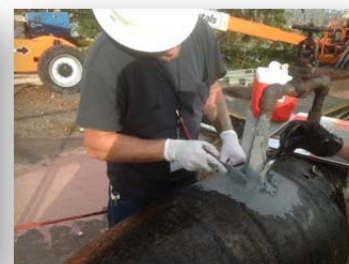
Final coat
