## CASE STUDY

**PROJECT:** Crude Oil Pipeline Repair  
**OWNER:** Seplat Petroleum (E & P)  
**DATE:** June 20-24, 2018  
**PRODUCTS:** MCOR 3115 | mClad mFill™  
**LOCATION:** Sapele, Delta State, Nigeria  
**CONTRACTOR:** Aniz Allied Services Limited  
**ENGINEER:** Afolabi Ogunmefun & Isaac Ejuomah

#### Crude Oil Pipeline Repair

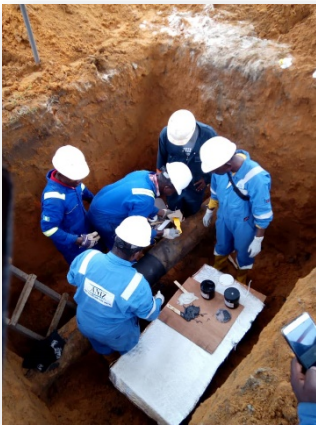
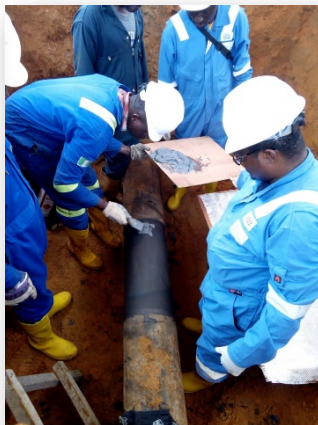
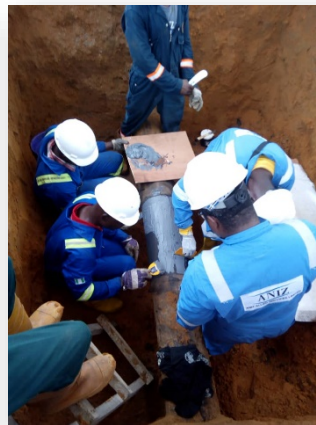
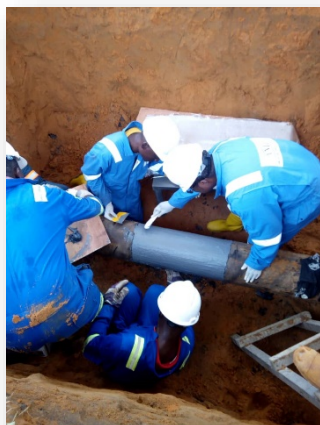
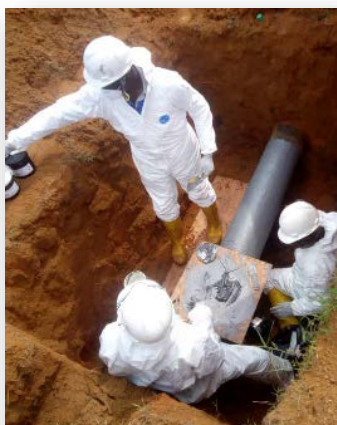
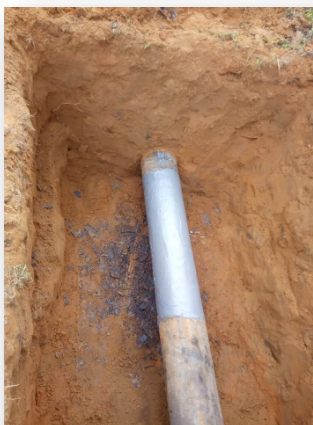
Metal loss due to corrosion made reinforcing this pipeline essential to avoid potential loss of containment.

Because the pipeline is pressurized, and the bonding would be supported with reinforcement, surface preparation involved solvent cleaning to SSPC-SP1, “Solvent Cleaning Removal” to eliminate all visible oil, grease, soil, and other soluble contaminants from steel surfaces, including removing loose rust and other contaminants. The contractor, Aniz Allied Services Limited, prepared MCOR 3115 | mClad mFill per MCOR specifications, and the pipe defect was filled/coated 2 mm thick with the fiberglass cloth impregnated and laid into the coating while still wet soon after.

Immediately after the initial stage of application (direct-to-steel filling + fiberglass reinforcement layer), the fiber reinforcement was recoated with another 2.5 mm of MCOR 3115 as an overlay and allowed to fully cure. An approved thinning agent was then used to allow fluid flow and viscosity for the final top coat.
