**PROJECT:** Pump Impeller – Restore & Coat  
**OWNER:** Coral Gables, FL TP  
**DATE:** 2012  
**PRODUCTS:** MCOR™ 3310 | mClad™ Metal  
MCOR™ 2101 | mPlait™ MP

#### Even the Most Deteriorated Mechanical Parts Can Be Rehabilitated

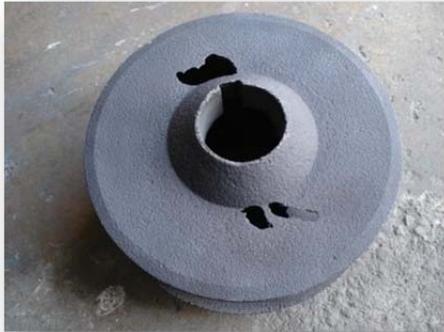
Proper surface preparation is key.

Prior to the application of these products, proper surface preparation was necessary, as in all rehabilitative coating jobs. The success of any coating application is directly proportional to the completeness of the steel preparation. The surface must be completely clean and sound. In this case, the pump was blasted down to its near-white metal finish to remove rust. This process made the holes caused by corrosion visible and easy to address.

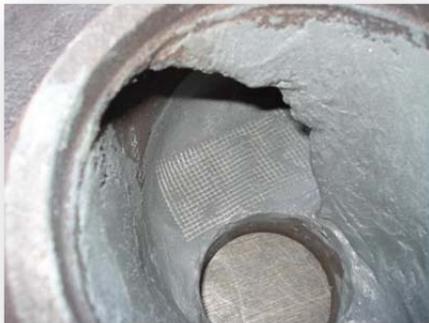
Fabric reinforcement was placed over the holes to provide support and bridge the holes.

Fabric reinforcement was placed over the holes to provide support and bridge the holes. MCOR™ 3310 | mClad™ Metal, an engineering-grade, steel-alloy-reinforced epoxy, was then used to resurface and fill. This paste grade polymer restores, repairs and reclaims metal and is often utilized as a high strength structural epoxy filler for load-bearing correction, tooling, and machining. Once cured, the material replaces worn or lost metal and restores the metallic profile with poly-mechanical bonding and reinforcing as a cold-weld alternative. It exhibits good heat tolerance and advanced wear resistance cladding as a solution for a wide range of industrial applications.

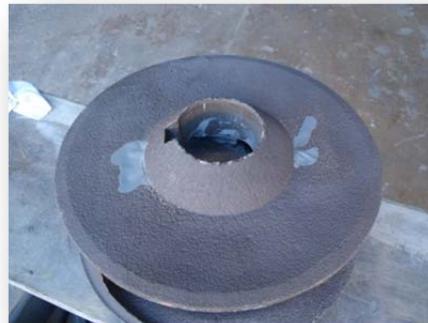
MCOR™ 3310 was then used to reclaim

MCOR™ 3310 | mClad™ Metal cured in approximately 24 hours for return-to-service. As a topcoat, MCOR™ 2101 | mPlait™ MP, a two-component low-to-medium- build ceramic epoxy coating, was used. Ceramics are proven technologies for combating the effects of wear and abrasion. MCOR™ 2101 | mPlait™ MP is combined with advanced curing agents and fluoroceramics. The cured ceramic material provides incredible resistance to chemical attack. It works well for most industrial applications requiring chemical resistance and abrasion protection, with a leveling-grade, controlled build-up for precise fitting and thickness.
