MCOR[™] ABILITIES[™]

CASE STUDY

PROJECT: Gas Butterfly Valve – Restore & Coat
OWNER: City of Hollywood, WWTP
DATE: January 2007
PRODUCTS: MCOR[™] Primecoat[™] MTe
MCOR[™] 3115 | mClad[™] mFill[™]
MCOR[™] 2101 | mPlait[™] MP

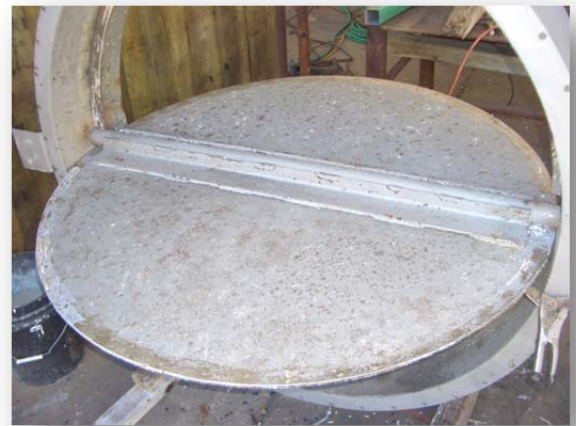
The City of Hollywood is a municipality that works with vendors such as MCOR[™] to solve mechanical issues on a routine basis. One such issue involved their butterfly air valve, used to cease flow of gases as part of the sewer treatment plant's operation.

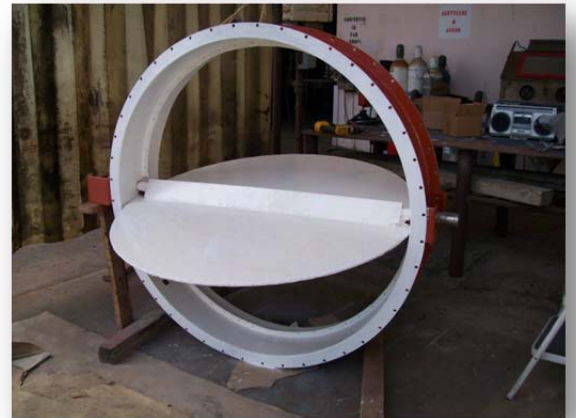
When the structure was removed from service, obvious surface corrosion was visible, and after a closer look, because of the flow of gas, some of the corrosion actually carved and pitted the steel.

The project was straight forward from MCOR[™]'s perspective - restore the surface (reclaim the lost pitting of metal back to its original profile) and make sure the metal was well protected for future service cycles. From a cooperative stand point, with MCOR[™], the products would be safe, simple, and effective.

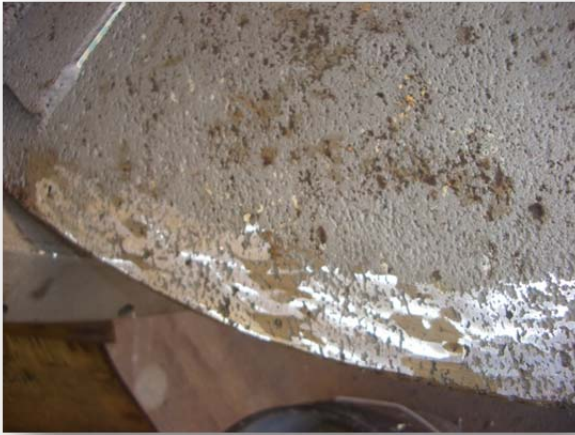
Visible corroded metal confirms harshness of the gas flow

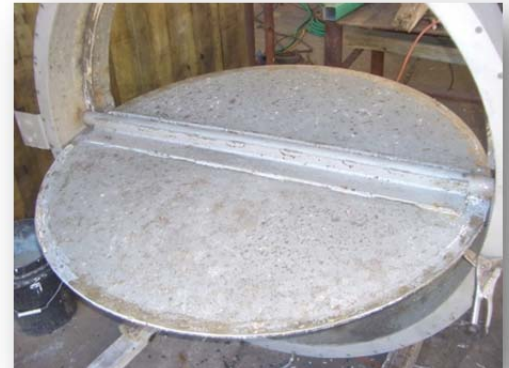
To begin, the surface was abrasively blasted to a SSPC-SP6 / NACE 3 “Commercial Blast Cleaning.” Being in S. Florida, flash rusting (a quick occurring, thin layer of oxidation) occurs very soon after blasting, to avoid this, immediately after blasting, crews applied a holding primer- MCOR™ Primecoat™ MTe, a metal base coat with rust inhibitors.

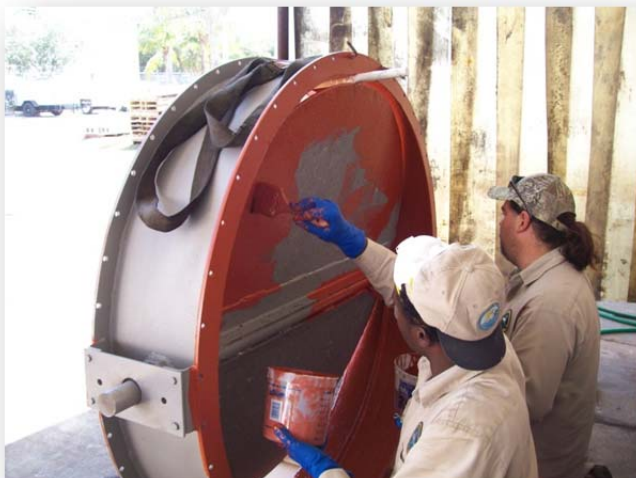
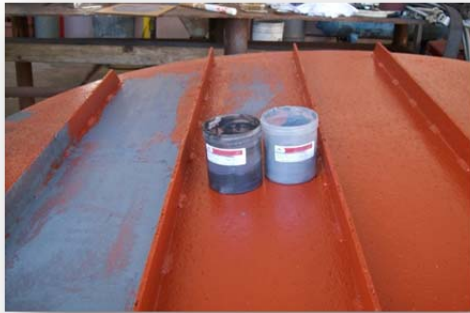
After priming, the application of the MCOR™ 3115 | mClad™ mFill™ began. The application was simple, with a 1:1 mix ratio by volume. A manageable amount of polymer repair paste was used to fill in all voids and pits to the corroded steel, directly on top of the primer.

Filling in pits and resurfacing metal with MCOR[™] 3115 | mClad[™] mFill[™]

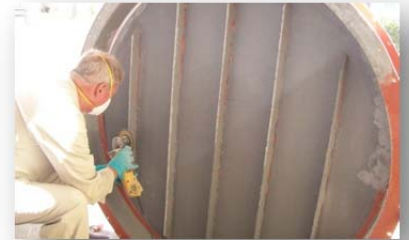
Sanding and detail dressing of the 3115

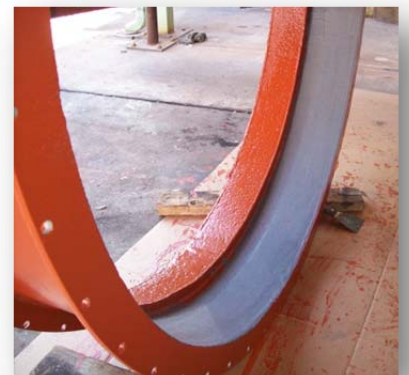
mClad[™] mFill[™] restores the flange face for a proper seal

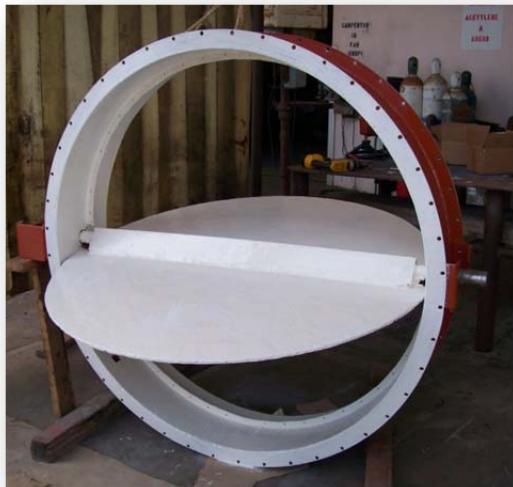
Two coats of MCOR[™] 2101 ensure ceramic protection against further corrosion and chemical attack

This final step, the protective coating application, was done with the MCOR[™] 2101 | mPlait[™] MP. The mPlait[™] MP is a ceramic coating offering a high level of abrasion protection. It is cured with novolac and endures high levels of chemical and microbial induced corrosion, such as those found in sewer gas environments where this butterfly valve is utilized.

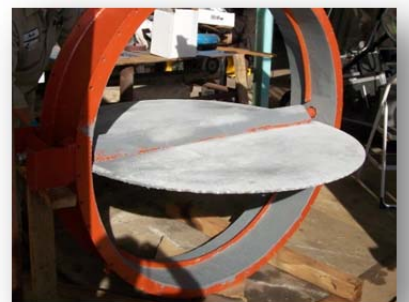
Steel surface restored in its entirety
