PROJECT: Rooftop Exhaust Fans

LOCATION: Martin Luther King Office Building, Miami, Florida

EXHAUST FAN REPAIR with MCOR 1110 | mCoat IM

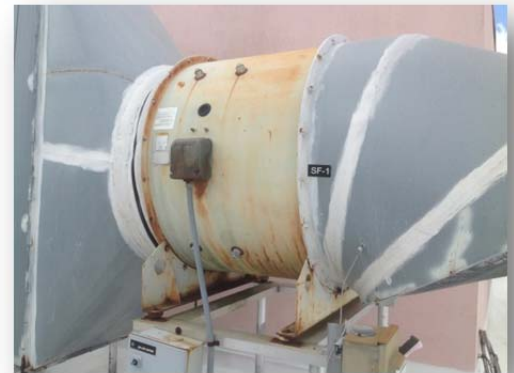
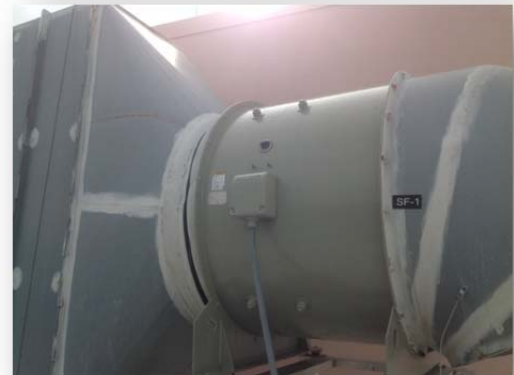
The property management company for the Martin Luther King Office Building, located in Northwest Miami, Florida contacted MCOR[™] in June 2015 regarding its rooftop exhaust fans. The company's Senior Engineer was particularly concerned about the premature corrosion observed on the exhaust fans.

Before beginning the application, Prime Tech Coatings prepared the surface of the exhaust fans by properly degreasing the fan housing (SSPC-SP 1 "Solvent Cleaning"). The surface was hand tool cleaned, wire brushed (SSPC-SP 2 "Hand Tool Cleaning"), sanded, and then profiled using a "Monti" bristle blaster. They then applied the MCOR 1110

| mCoat IM by brush and roller for a smooth finish. The next day a second coat was applied. The entire project was complete within two days.

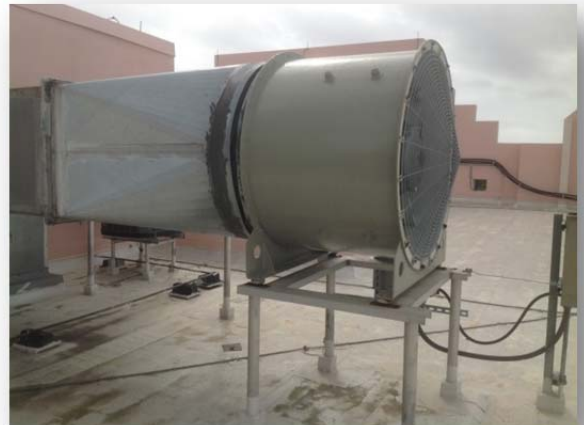
After

Several months later, an MCOR representative inspected the project to see how the product had held up during an unusually wet winter season in South Florida. The results demonstrate the quality of MCOR 1110 | mCoat IM in protecting this substrate against corrosion and providing a long-term solution.
