PROJECT: Concrete Trough of a Wall-Mounted Water Fountain
OWNER: City Hall in San Fernando, Trinidad
DATE: April 2016
PRODUCTS: MCOR™ 5101 | mCrete™ R Gel

City Hall Wall-Mounted Water Fountain Repaired with MCOR 5101™

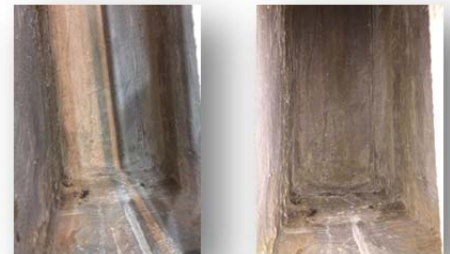
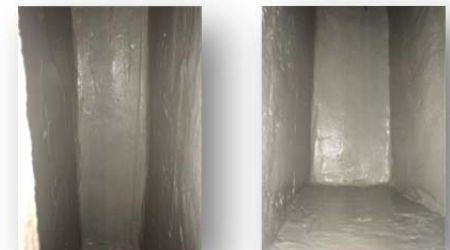
The interior of the building reflects similar architecture as the exterior, including a wall-mounted water fountain which was in need of some attention. The fountain's trough had small hairline cracks throughout. The fountain was leaking and needed to be sealed and recoated in order to function properly and control the leaks.

Fountain Trough - Before and After

The surface preparation was a simple acetone cleaning. MCOR 5101 | mCrete R Gel was then mixed and applied. All MCOR product kits come equipped with a mixing board and all necessary tools, making the product application easy and quick. MCOR 5101 was mixed using a 1:1 ratio until there were no visible streaks or lumps. The wide plastic putty knife (supplied in the kit) was then used to spread the product evenly, at a thickness of 1/16", filling the fine cracks in the process.

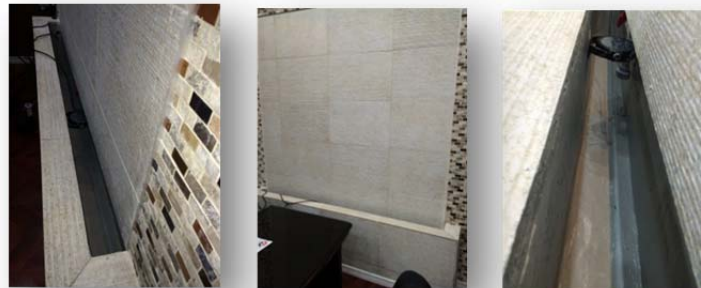
The completed restoration of the concrete trough for the city hall mounted water fountain using MCOR 5101 | mCrete R Gel created a shell-like protection over the old, existing coating and stopped all the leaks that previously existed.

Completed City Hall fountain trough restoration
