PROJECT:	Rehabilitation of Leather Draining Machine using MCOR 1298
OWNER:	Curtiembres BUFÁLO
DATE:	July 2017
PRODUCTS:	MCOR 1298 mCoat IM Plus:
LOCATION:	Barranquilla, Colombia

Rehabilitation of Leather Draining Machine Using MCOR 1298

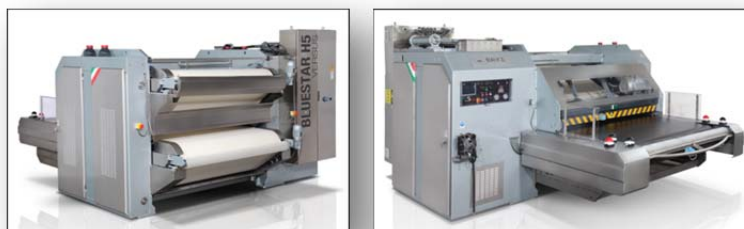
Leather Draining Machine

During the operation of leather draining machines, the metallic walls are constantly exposed to a series of aggressive chemicals such as caustic soda, sulfuric acid, chromium salts, and sulfides, which attack and cause damage via oxidation. In this particular case, the metal walls of this leather draining machine had moderate oxidation and corrosion.

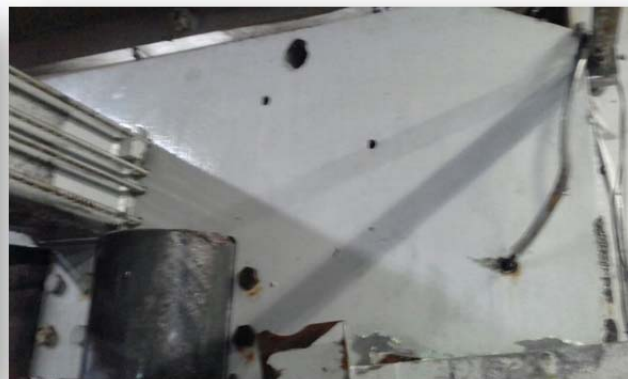
Surface Preparation: – Metallic Walls after Hydro-blast

Surface preparation began by hydro-blasting the substrate to remove grease, oils, and other contaminants from the surface. Next, the surface was mechanically cleaned with grate metal and sandpaper to obtain a suitable anchorage profile for the coating application.

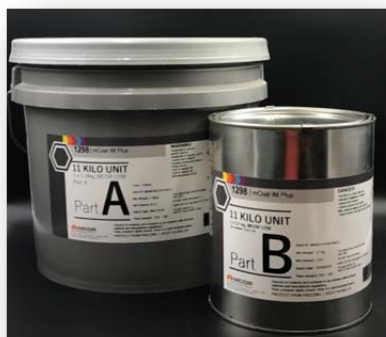
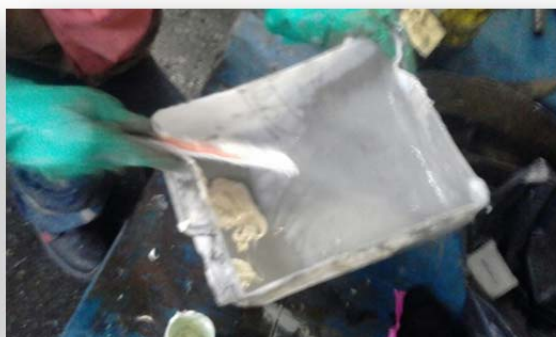
MCOR 1298: Product Mixing and Application

Once the surface preparation was complete, Parts A and B were mixed in proportions according to specifications. After obtaining a uniform mixture, the product was immediately applied to the metal walls of the draining machine. MCOR 1298 was applied at a thickness of 40 mils, thickness and the machine was returned to service after 72 hours.

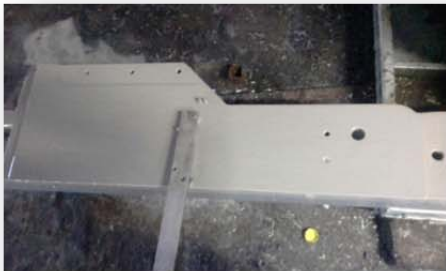
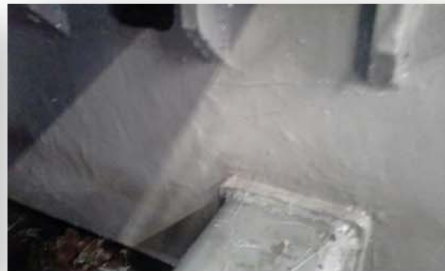
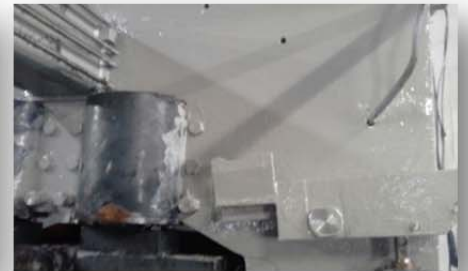
Final Look

The simple application of MCOR 1298 allowed this machinery to be restored rather than replaced, saving Curtiembres BUFÁLO time and money. All parties involved in this rehabilitation were pleased with the ease of application and the results of the refurbished machinery, which will provide for years of protection and preservation.
